Single Survey

survey report on:

Property address	25 Reform Street Montrose DD10 8RP
-------------------------	--

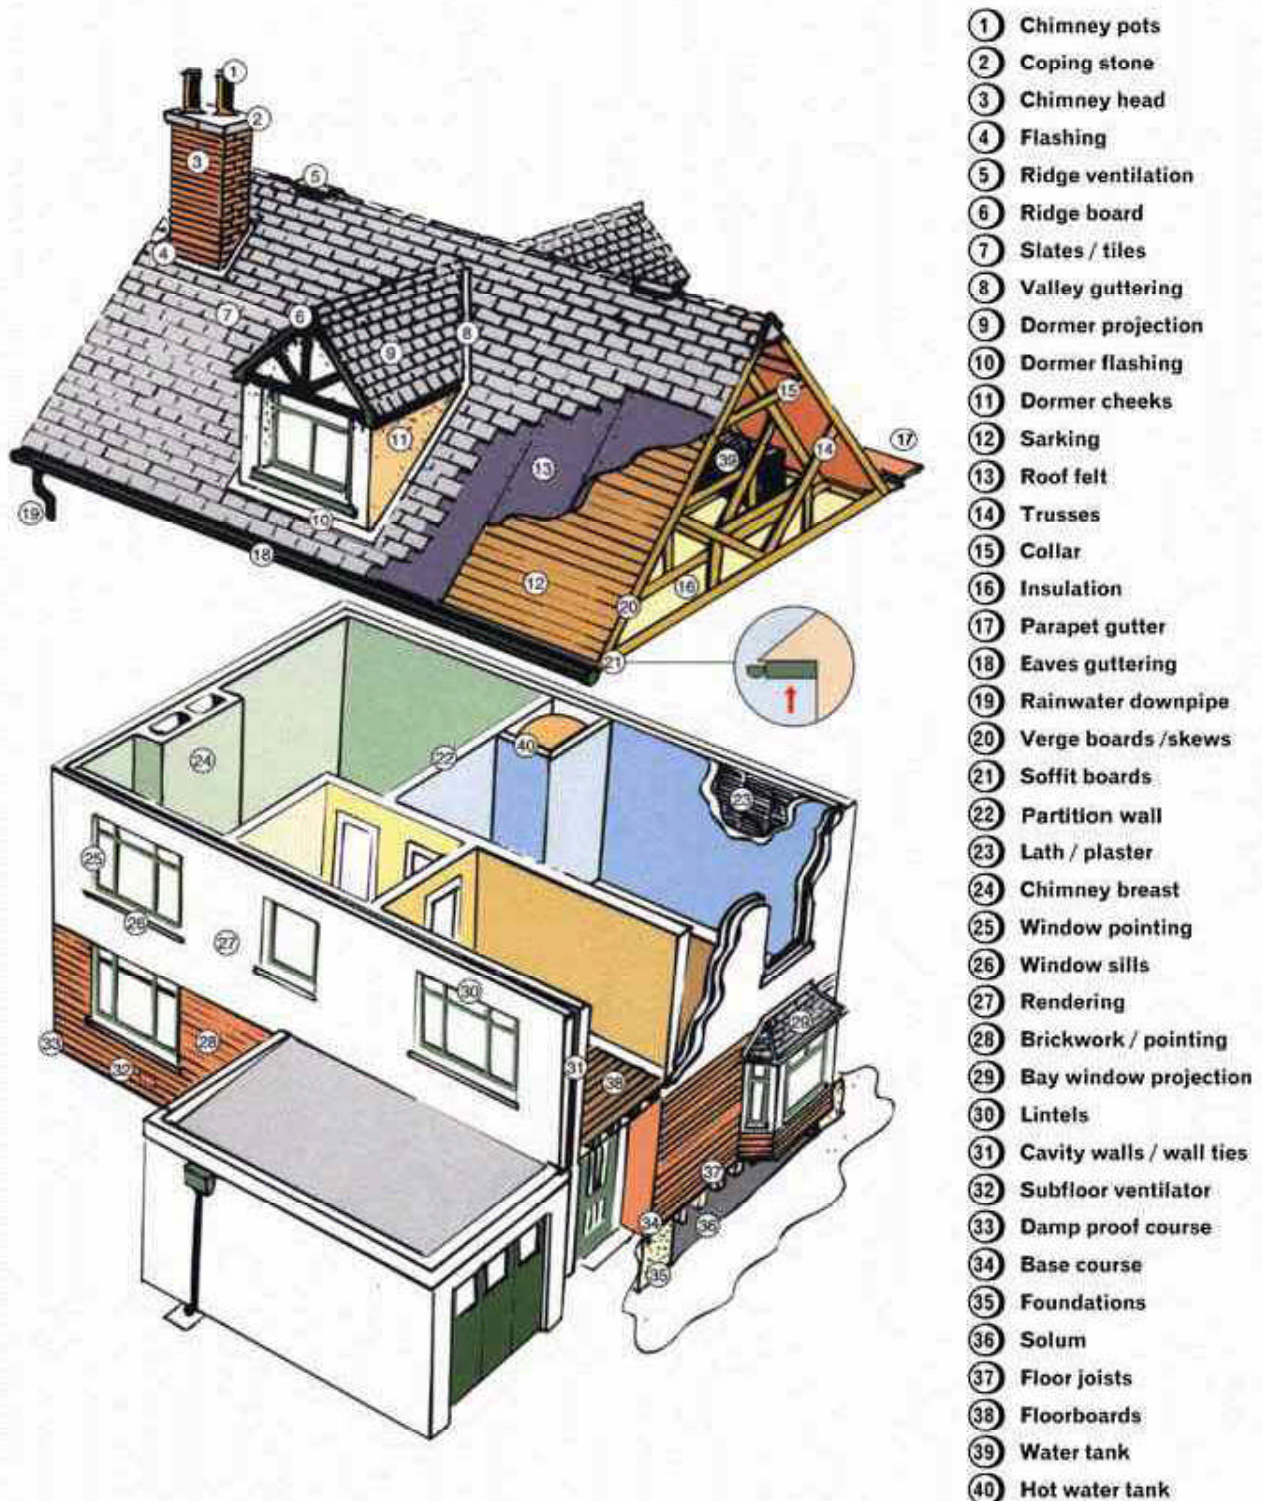
Sectional Diagram showing elements of a typical house

Reference may be made in this report to some or all of the above component parts of the property. This diagram may assist you in locating and understanding these items.
